RESTORATION ANALYSIS OF KURANJI DAM DUE TO SCOURING AT THE DOWNSTREAM

Key words: Scouring, Masonry Dam, Unreinforced Concrete, Restoration

Cite this Article: Dr. Bambang ISTIJONO and Abdul HAKAM. Restoration Analysis of Kuranji Dam Due To Scouring at The Downstream, *International Journal of Civil Engineering and Technology*, 7(2), 2016, pp. 321–327.

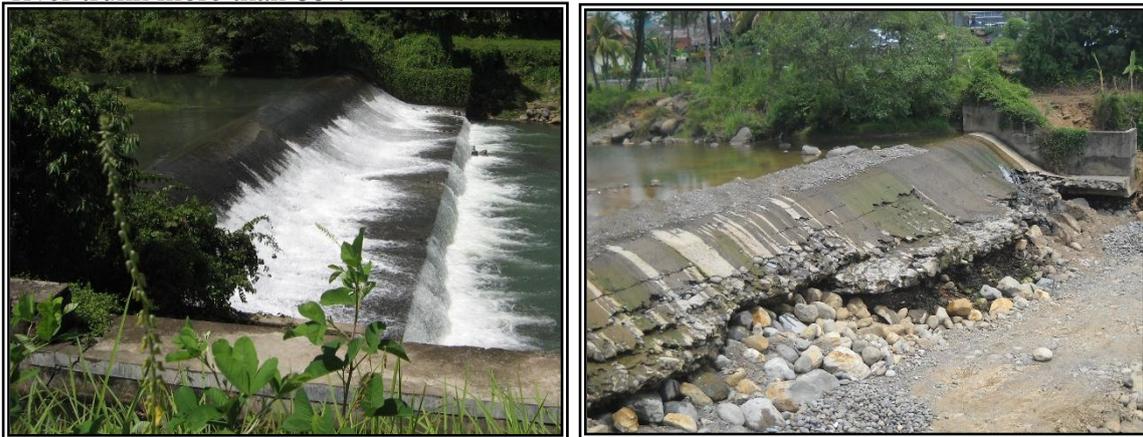
length of about 27m is damaged due to scouring at the downstream foundation. This scoured foundation has caused a lost of support on the tail of dam structure. This condition then led to the load of the flood water and the debris could not be supported hence damaging the downstream of dam structure. This scoured foundation also led to the failure of intake facility of irrigation water and drinking water in the dam. Figure 1 shows the conditions of the sub-dam at before and after the disaster.

Figure 1 The condition of the sub-dam at before and after Galodo 2012

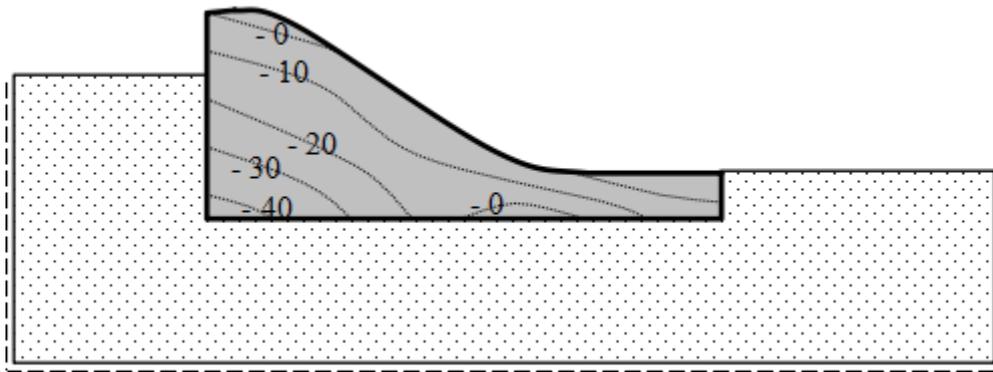
Simulation of the dam structure is done by considering the original of the dam before damage, the initial scouring of the foundation and after damage occurred. The results of the numerical software program are then redrawn to give better illustrations of the problems. In the original condition, it can be seen that the dam of Gunung Nago is in a very good condition. It means that all parts of the dam body in a state of compressive stress. This situation is really ideal for concrete and masonry without reinforcement (Figure 3). The compressive stresses are very small compared to the strength and the dam is still in a safe condition. The maximum stress value is only 5% of the compressive strength of the rock river masonry material.

Figure 3 Stress on dam in initial condition

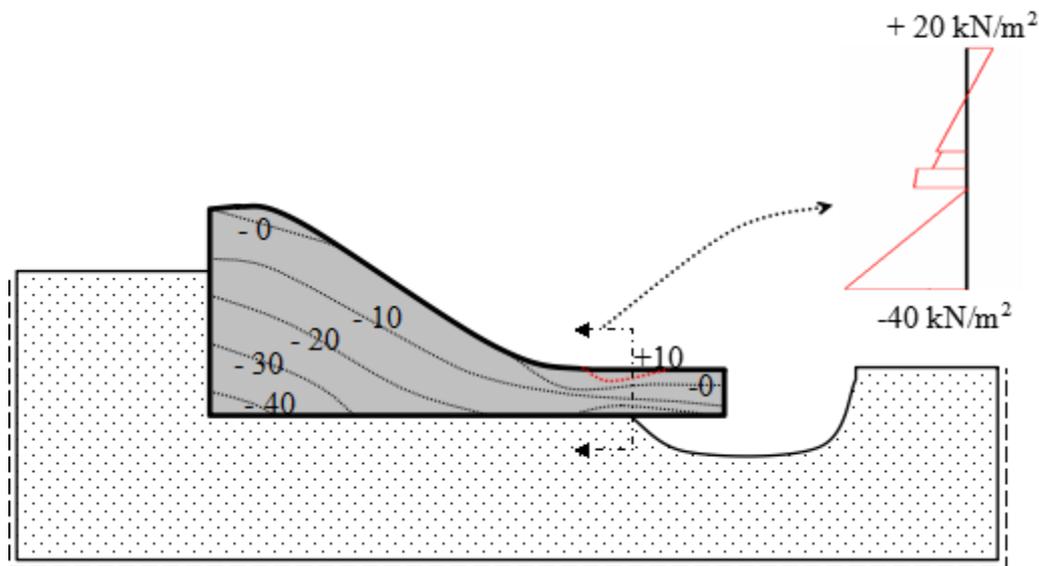
At the beginning of the scouring conditions at the base of the foundation, the dam of Gunung Nago is still in good condition. Most of the part of the dam structure are in a state of compressed. At this time there is tension stress began on the upper part of downstream tail (Figure 4), but the dam is still in very safe conditions. The maximum tensile stress in that section is only about 10 kN/m² or about 1% of the tensile strength of the masonry material.

Figure 4 Stress on the dam in beginning scouring condition.

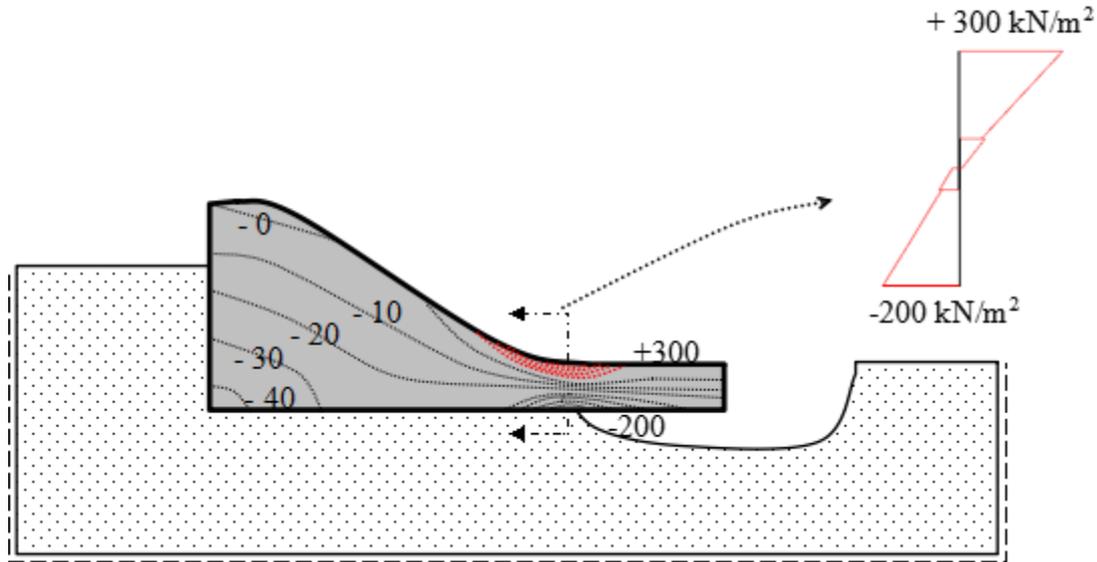
At the scouring state that reaches as long as 1.5m on downstream dam, the stress of the Gunung Nago dam condition has been already on a safe boundary conditions. Even the most part of the dam structure is still in a state of compression, however at this time the are fairly large tensile stress on mid-upper parts of the dam (Figure 5). The maximum tensile stress occurs at the boundary safe condition. The maximum tensile stress value in that section is about 300 kN/m^2 , or about 30% of the tensile strength of the material where the safe limit values for tensile stress is allowed.

When the soil conditions below the dam foundation scoured up to 1.5 m, it can be seen that the upper part of the dam structure was at the limit of safety against tensile. At that time, the upper part of the dam in which its base began to loos the soil support, is started to damage during the flood. Mechanically the values of tensile stresses in this conditions are remain in limit of allowable strength. Theoretically the dam is still able to give the service if it is repaired with the same material that is the river rock masonry.

Figure 5 Stress on the dam in limit safe condition.

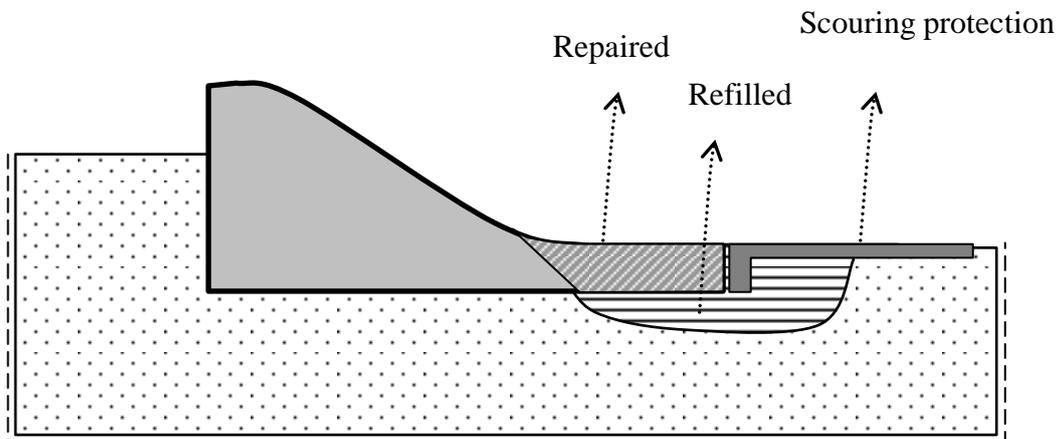
Figure 6 Quick and appropriate restoration for the dam

Based on these results, the appropriate restoration that need to be done only by filling the section below the dam back to the original condition (Figure 6). Then the dam is repaired as same as the original one. Furthermore, to avoid the occurrence of scouring at the base of the dam foundation, it needs to make an additional apron on the downstream side of the dam as a scouring protection.

Most part of the river stone masonry dam is still stable at post the Galodo disaster. Based on the analyses, Since it was showed that the stresses occurred in the body of the dam is still in safe condition, then the corrective action that is quick and accurate is refilling the soil on the base that has been scoured followed by the reconstructing

the dam with the same material. To protect the dam against the scouring in the future, it needs to build the ground sill on the downstream of the dam as a scouring protection structure.
