FUNCTIONAL AND STRUCTURAL EVALUATION OF A ROAD PAVEMENT

In the present it is proposed to carry out both of them for a selected section of pavement on a State Highway in Tamil Nadu, India, the details of which are given the methodology

The study location identified in the present work was between Budalur and Pudupatti section (8.6km to 11km) of State Highway 99 (Thirukattupalli - Sengipatti - Pattukottai road). For the purpose of functional evaluation the total the pavement length was divided into 8 sample units of equal size. Each sample unit is 300m x 7m. For convenience, 5 out of the 8 sample units were considered for inspection by random sampling technique. Manual distress survey is conducted to identify the presence of various distresses like rutting, potholes, patching, raveling, shoving, etc. in the pavement surface. The percentage area of each distress present in each of the inspected sample units was calculated. Each section is rated as per the IRC: 82 - 2015 guidelines. The functional condition of the pavement is assessed to be good, fair or poor based on this rating. The overall pavement condition is also determined. The characteristic deflection of the pavement is dete

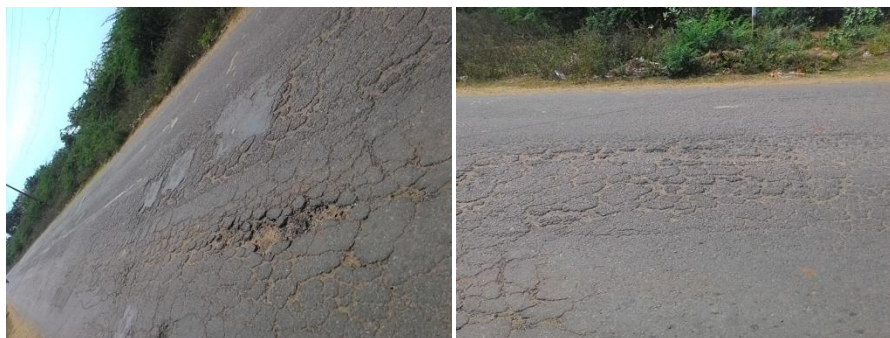
Figure 1 Distress survey

Manual distress data collection is done to identify the various distresses present in the pavement section. A rating in the scale of 1 to 3 is given to each distress based on the percentage of distress present in the pavement and the weighted rating value of the pavement is calculated to assess the pavement condition as per the guidelines given in IRC82:2015. The results of the evaluation are as follows.

It is observed that there are several distresses like alligator cracking, longitudinal cracking, transverse cracking, rutting, potholes, patching, etc present in the pavement. The pavement is divided into sample units of equal size as there is homogeneity in the pavement and 5 out of 8 sample units are inspected by the principle of random sampling technique. All the sections have about 10% to 20% distresses in terms of surface area of distresses. The pavement is rated taking into consideration distress type and its quantity and it is found that all the pavement

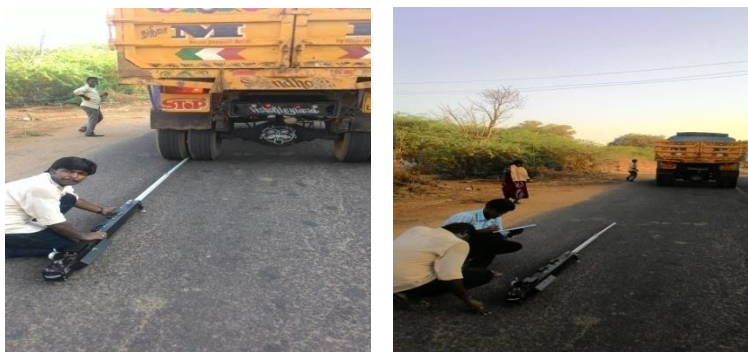
Figure 2 BBD data collection in Progress

The deflection in the pavement is measured using BBD technique. The procedure followed is as per IRC:81- 1997. Digital dial gauge which shows direct deflection readings has been used for the experiment. All the necessary data like pavement temperature, drainage system, etc. were collected during testing. Soil samples were collected at the test site for every 1 km interval and tested for moisture content and Plasticity Index values. The truck was placed at about 0.6m offset and the readings were taken for every 25m in alternating lanes. The readings are as follows.
