ROAD SAFETY AUDIT OF ANANTHAGIRI HILLS GHAT ROAD AT VIKARABAD DISTRICT

Cite this Article: N. Naveen and Dr. T. Ilango, Road Safety Audit of Ananthagiri Hills Ghat Road at Vikarabad District, International Journal of Civil Engineering and Technology, 9(4), 2018, pp. 816–825.

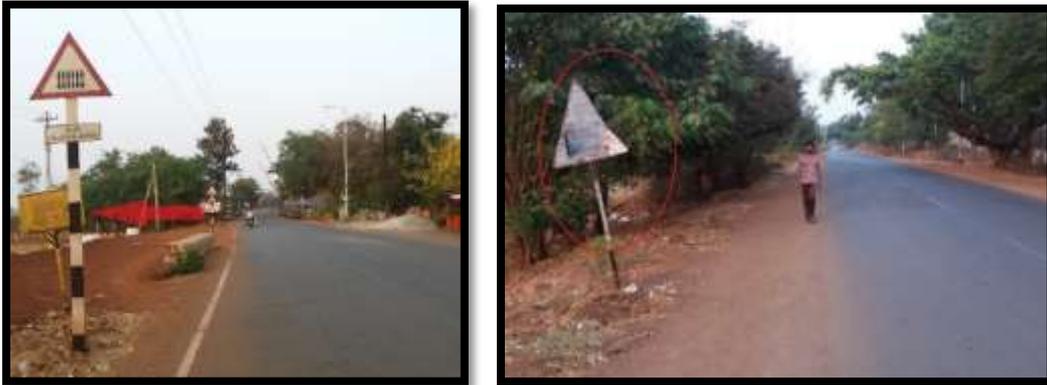
3.1. Observation: Traffic signs which are not authorized and faded are placed.

Figure 2 Unauthorized Traffic sign/ Legibility on the traffic signs is inadequate

Reason for Concern: This creates confusion to the driver and it decreases the respect towards traffic signs.

Recommendation: Proper sign placements need to be done and the unwanted signs need to be removed.

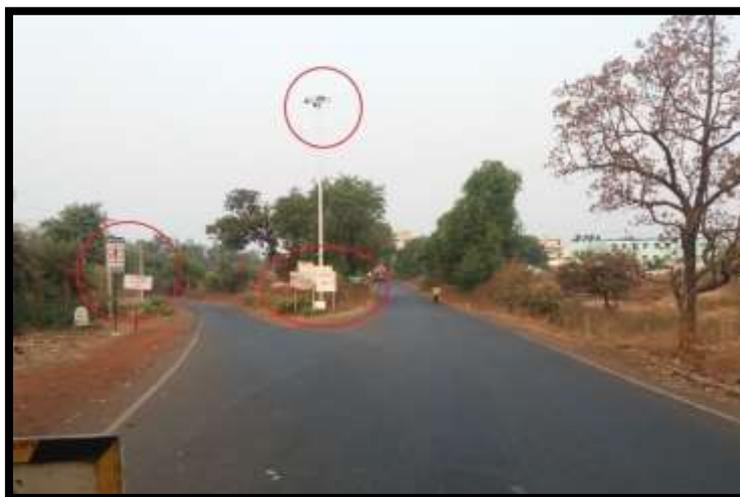
3.2. Observation: Numerous sign placed at a junction. Illumination of the junction had done with the street lights.

Figure 3 Too many signs placed at a location/Illumination the diversion road

Reason for Concern: Placing of advertainment boards, Route signs and traffic signs at a same place is not good and it causes fatigue to the drivers. Driver may not able to find out the traffic signs from all these boards.

Recommendation: Unwanted signs which create confusion and fatigue need to be removed. Longitudinal distances of 10 meters need to be maintained between the signs. It would be better if road markings are provided at junctions.

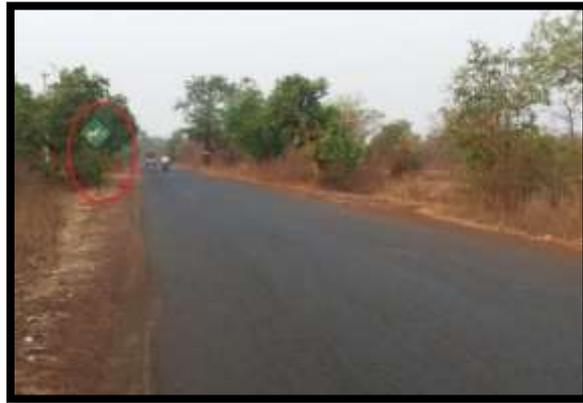
3.3. Observation: Though the sign is not standardized, it is showing the place of animal crossing the road. The sign may be installed by the Forest Department.

Figure 4 Indication of Animal crossing area

Reason for Concern: Placing of this sign helps the vehicular to reduce their speed and be cautious about the safety of forest animals.

Recommendation: Along with the standard animal crossing sign board, speed limit tag/sign need to be installed.

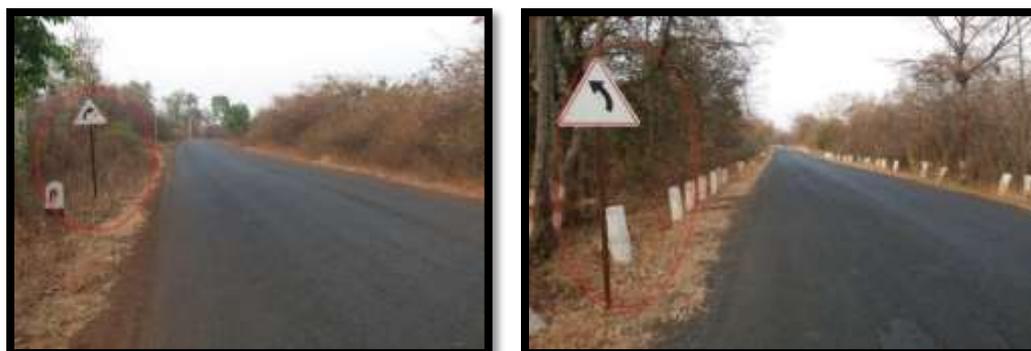
3.4. Observation: Red border of the sign board is not solid line. The sign board cannot be easily identified by the driver. The height of the sign is less than the standards. The sign post is not in a good condition.

Figure 5 Nonstandard sign /Unauthorized sign

Reason for Concern: Non-standard signs have less respect in the vehicular view, thinking that they are old signs and need not to follow the rules.

Recommendation: Proper sign boards with red solid boarder need to be arranged. The sign height of 2.1 meters from the carriage way need to be maintained.

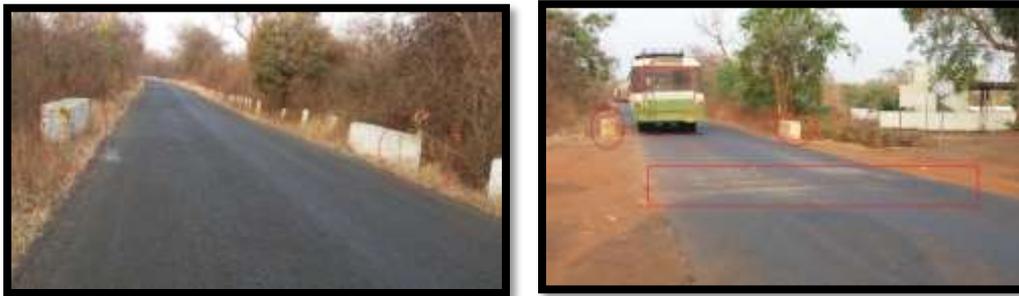
3.5. Observation: Presence of speed breakers not indicated by a sign board or a marking, Fixed road side Hazards.

Figure 6 Presence of speed breakers not indicated, fixed road side Hazards

Reason for Concern: Sudden change in the level of the carriageway throws away the vehicle from it. Culvert walls may be a hazard to the errant vehicles. It can become a black spot.

Recommendation: Sign boards indicating speed breaker, two-way hazard marker sign board need to be installed at 120 meters ahead of the speed breaker. White solid transverse line need to paint ahead indicating speed breakers. Retro reflective stickers or paint need to be done on the culvert walls facing the traffic.

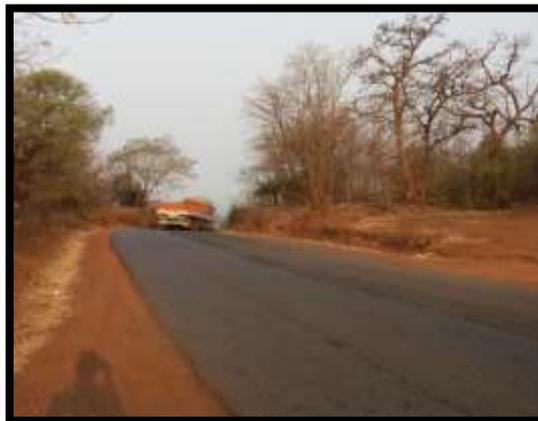
3.6. Observation: Absence of steep curve descent sign and series of bend sign

Figure 7 Absence of steep curve descent sign

Reason for Concern: Driver may not know the situation of the road ahead, moves with the same speed. This causes the vehicle to lose the control and may be a chance of hitting the wall or overturning.

Recommendation: Steep descent sign and series of bend sign need to be installed at 120 meters ahead of the hazard and chevron signs need to be arranged at the outside of the curve. This enables the drivers to decrease his speed and check his breaks.

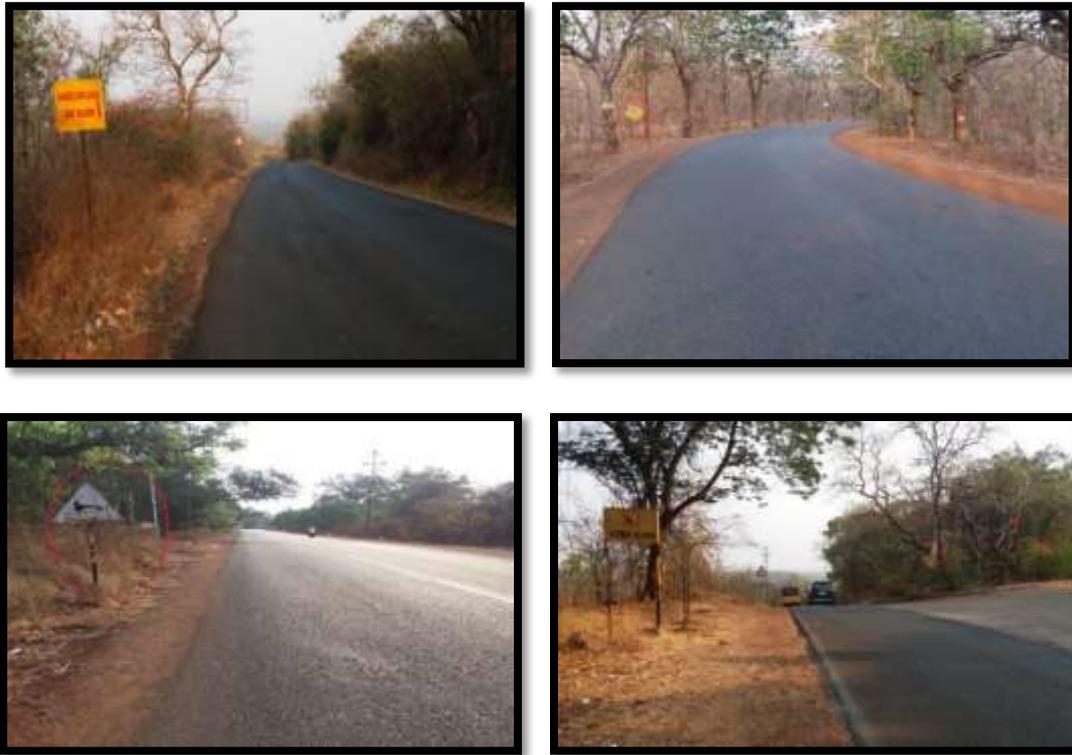
3.7. Observation: Non-standardized signs boards seen near the carriageway. The height/colour of the sign boards not matching the standards.

Figure 8 Unauthorized signs/ Nonstandard signs

Reason for Concern: Non-standard signs have less respect in the vehicular view and create stress to the driver, this leads to non-obeying of the traffic sign rules.

Recommendation: Proper warning sign boards need to be arranged, with a height of 2.1 meter from the carriage way

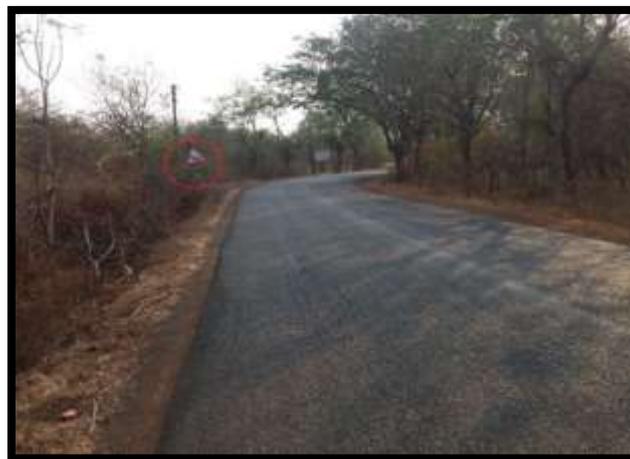
3.8. Observation: Sign board direction changed due to wind force.

Figure 9 Poor Maintenance of sign boards

Reason for Concern: Improper directional signs create confusion to the drivers and they mislead the travel time.

Recommendation: Proper maintenance of the sign board need to be done at regular intervals. Sign boards and markings need to be checked once in six months.

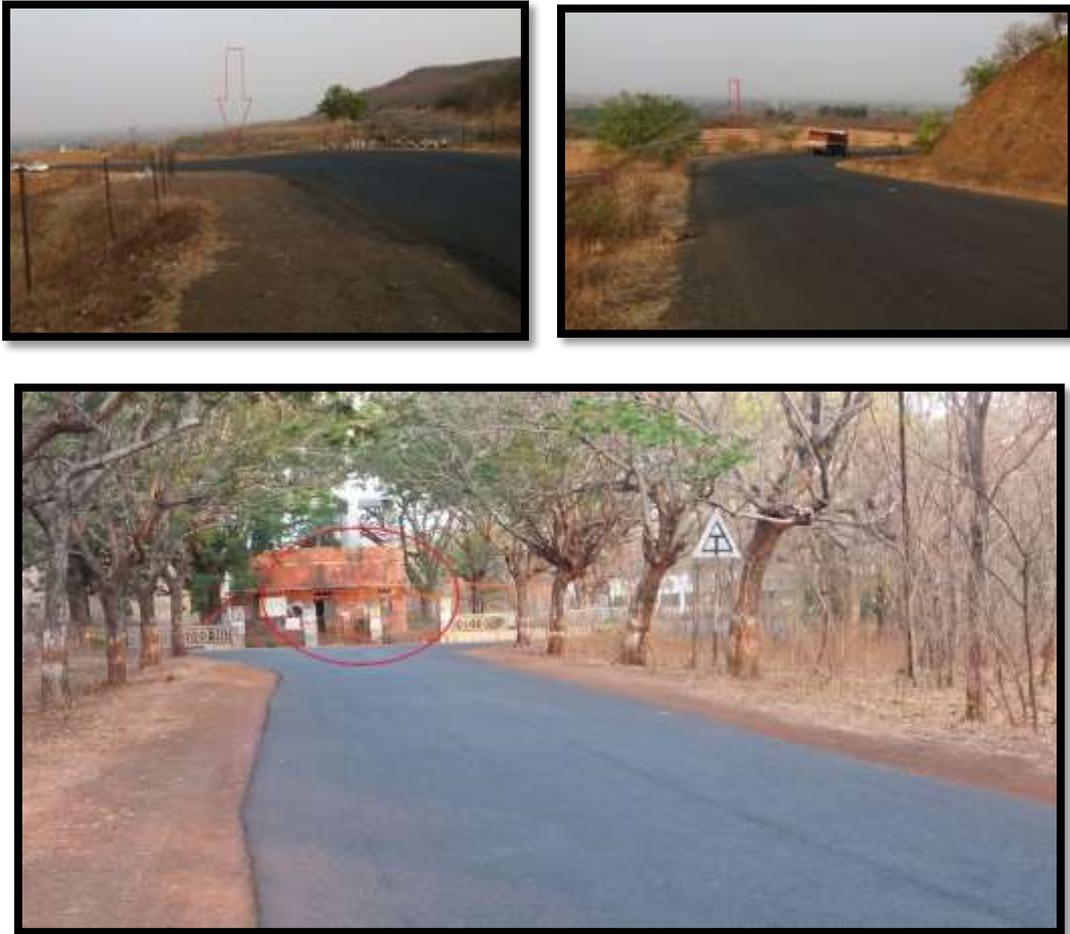
3.9. Observation: Sharp curves lessen the sight distance and create tension to the drivers.

Figure 10 Absence of Right/Left hand curve, chevron signs, Crash Barriers at a horizontal sharp curve

Reason for Concern: While moving on the sharp curves, the vehicular may not control with the same speed.

Recommendation: Clear indication of the curve need to be shown to the vehicular with Right/Left hand curve, chevron signs indicating the arrows towards turning. Crash barrier need to be installed at the outside of the curve.

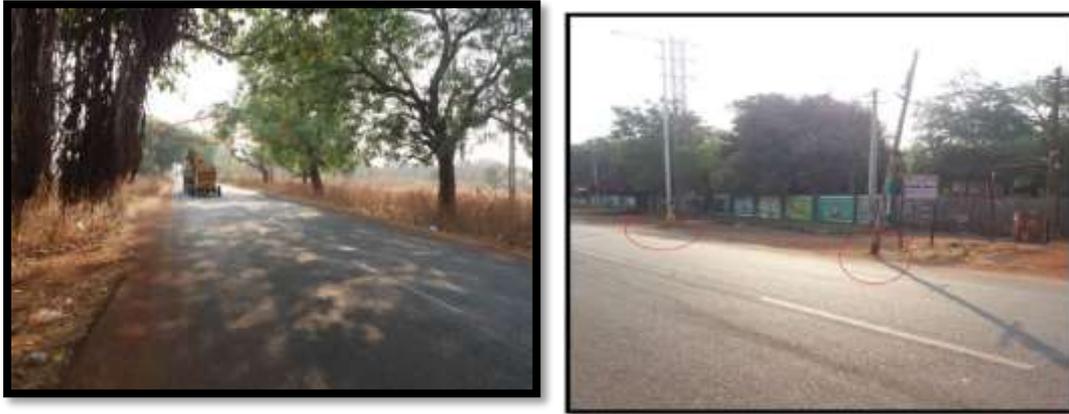
3.10. Observation: Tree Branches, Telephone Poles near to the carriageway.

Figure 11 Road side Hazards

Reason for Concern: This road side objects are very hazardous to the two wheelers and they can be hazardous to the window seaters in the buses.

Recommendation: The branches, poles near to the carriageway should be removed. Gap of 1.5 meters need to maintain from the road side objects to the carriageway end. Left side hazard marker need to be installed at 90 meters from the hazard. The road side hazards are to be marked in white colour to enhance the visibility.

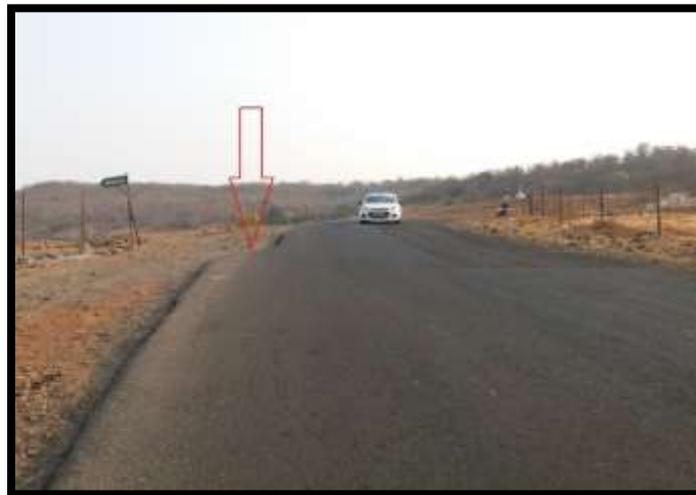
3.11. Observation: Sudden decrease of pavement width and dangerous dip at a horizontal curve

Figure 12 Absence of reduced carriageway sign and dangerous dip sign.

Reason for Concern: This gives no time to the vehicular to respond to the situation on the road and may lead to the overturning of the vehicle, or vehicle moving out of control.

Recommendation: Proper lane joining need to be done and width is maintained same throughout the road. Adequate shoulder width needs to be maintained to avoid inconvenience. To make the driver known about the situation, proper sign boards need to be installed.
