RESTORATION ANALYSIS OF KURANJI DAM DUE TO SCOURING AT THE DOWNSTREAM

Key words: Scouring, Masonry Dam, Unreinforced Concrete, Restoration

Cite this Article: Dr. Bambang ISTIJONO and Abdul HAKAM. Restoration Analysis of Kuranji Dam Due To Scouring at The Downstream, *International Journal of Civil Engineering and Technology*, 7(2), 2016, pp. 321–327.

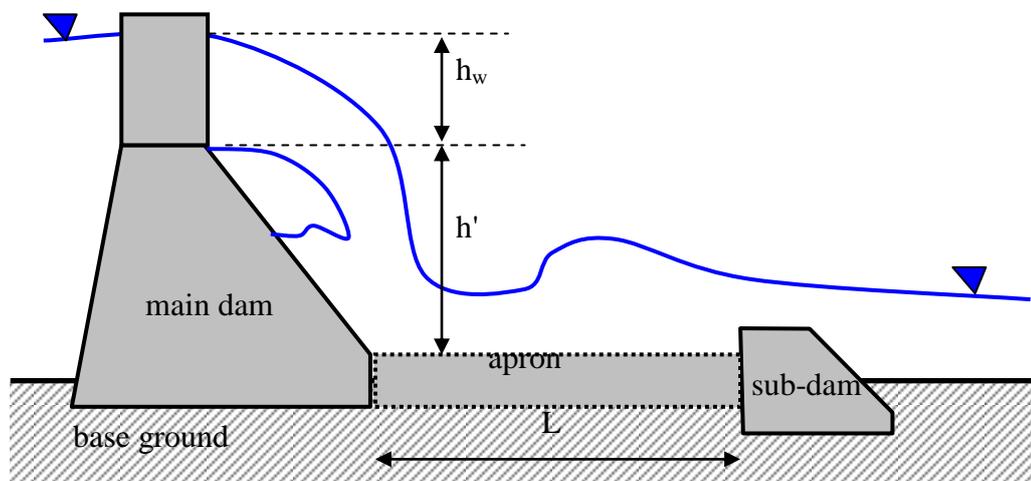
**Figure 2** Typical scheme of sub- and main- dam (PSDA West Sumatra, 2012)

Sub-dam of Gunung Nago is a dam that serves primarily to protect the main dam at the upstream section. A typical picture of the sub- and the main- dam used in Batang Kuranji is plotted in Figure 2. The Gunung Nago sub-dam is made of river stone masonry. The riverbed at the dam site consists of sedimentary rocks with the size up to boulder. The rock size can in fact be scoured and transported by strong water currents. In some case the lower side of groundsill can also be eroded so that the foundations of the dam losing the support. This situation makes the tensile stress on the upper side of the dam. The flash flood that carry heavy sediment, may result in a more high tensile stress on the upper side of the dam that may cause the lost bond in the masonry structure.
