NDT TECHNIQUES APPLIED FOR THE INSPECTION OF FLARE STACKS

Cite this Article: Carlos Martín-Díaz, María Dolores Rubio-Cintas, Kissi Benaissa, NDT Techniques Applied for the Inspection of Flare Stacks, *International Journal of Industrial Engineering Research and Development*, 9(2), 2018, pp. 01–12.
<http://www.iaeme.com/IJIERD/issues.asp?JType=IJIERD&VType=9&IType=2>

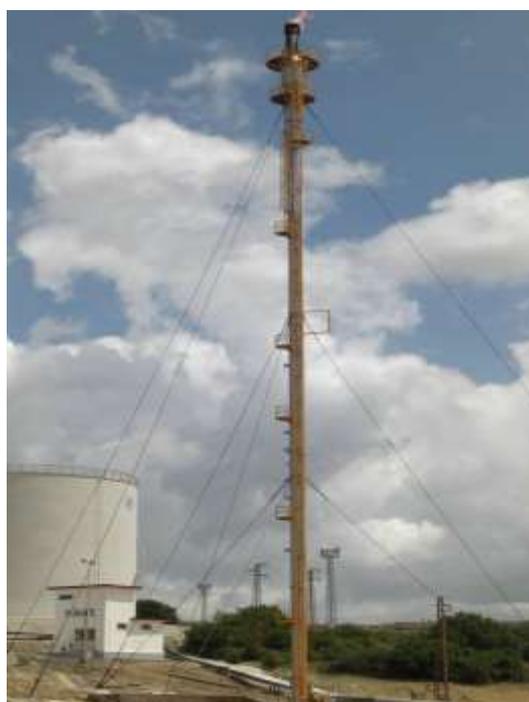
Figure 1 General view of a typical flare stack supported using guy wires

- Self-supported flare stacks, with a smaller affected surface area, suitable for heights of up to 76m and with a low manufacturing cost (photo 3).
- Supported using guy wires or cables, greater affected surface area of ground, heights of up to 180m and average manufacturing cost (photos 1 and 4).
- Supported by a permanent (photo 5) or temporary (photo 6) metal tower (derrick-supported). Small affected surface area, heights of over 200m and high manufacturing cost. Mentioned separately, although this group would also have to include flare stacks for offshore platforms.

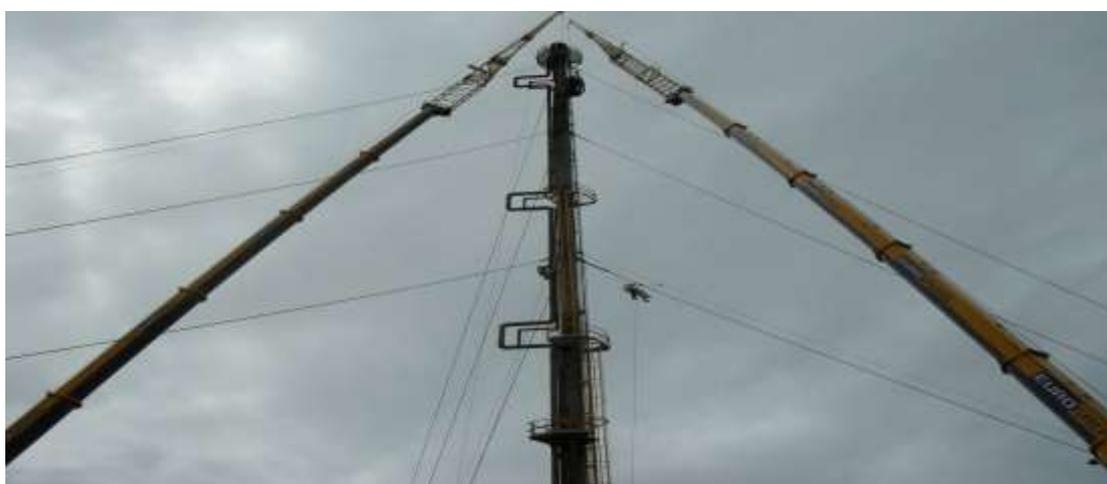
Figure 2 Works on a flare stack using cranes and baskets, combined with rope access techniques for the inspection and lubrication of guy wires

Access using rope access techniques (photo 2) is currently on the rise; rope access equipment, which is ever more advanced and safe, allows expert personnel to gain access to any part of the flare stack with limited means and great speed. This speed and versatility is the main advantage, the problem being the limitation in the work to be performed (this cannot involve heavy loads), but they are very useful in the case of the application of NDT. The use thereof, as well as the use of scaffolding, is regulated by European directive 2001-45-EC on "Temporary Rope Access Work" [9], in line with the requirements of the current Legislation on the Prevention of Occupational Risk [10] (European Directive 89/391/EEC).

Elevation platforms with a telescopic arm [11] or baskets supported by cranes (photo 2) are particularly useful to perform maintenance operations, for example, the replacement of the burner of the flare stack, replacement of the metal platforms or access ladders, etc. On the other hand, using them for NDT is very expensive, as the cranes have certain limitations in terms of access and reach as a result of the existence of the guy wires of the flare stack and in many cases, different ground levels around the base of the shaft.

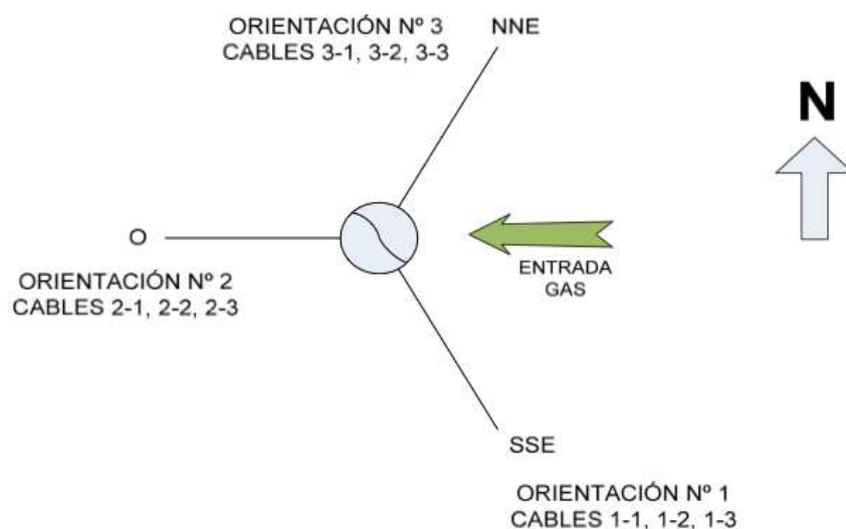
Figure 7 Terminology diagram of a flare stack with 9 guy wires in 3 orientations and on 3 levels

- Divide the flare stack into areas (1-2-3-4), coinciding with the orientation of the wires (generally three every 120°) or the pillars of the support structure (generally 4 every 90°).
- From the main gas entrance flange, each orientation can be numbered from 1 to 4 in a clockwise direction.
- From the ground to the top, each level of anchorage points (of guy wires or to a structure) can be numbered correlatively; 1, 2, 3, etc.
- Finally, each anchorage point can be assigned two digits, the first to indicate the orientation and the second the level of anchorage, for example, "anchorage 2-4" (the second in a clockwise direction from the gas entry point and the fourth in terms of height). This method allows the flare stack to be easily sectioned and avoids errors through the use of compasses in areas with possible interference from magnetic fields (photo 7).

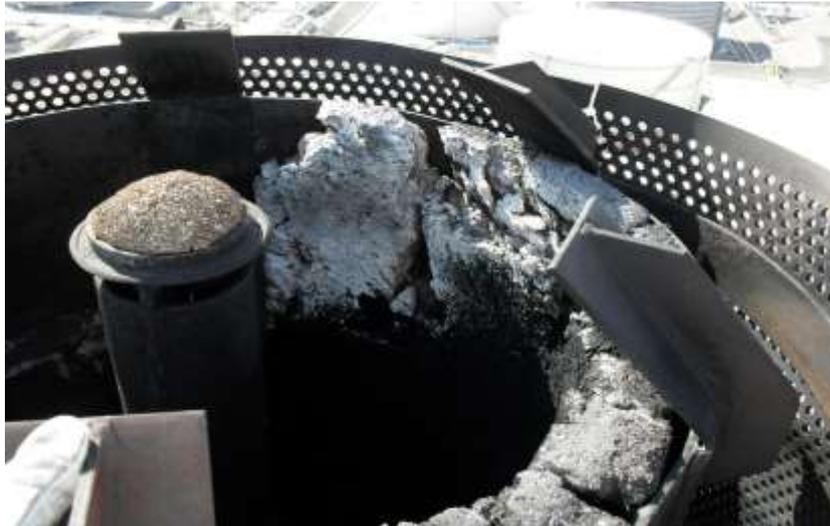
Figure 8.1 View from above of an installed burner, with detachment of fireproof coating

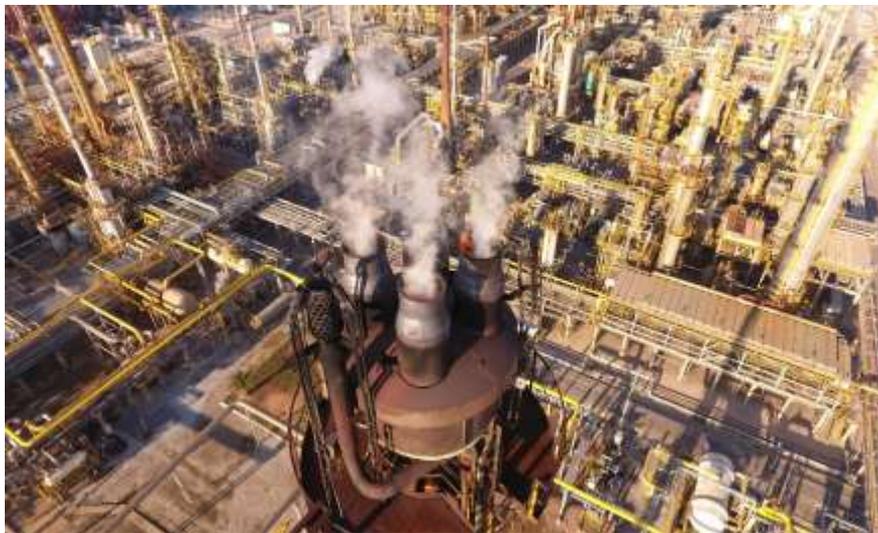
Figure 8.2 View from above of a burner in operation using drone inspection

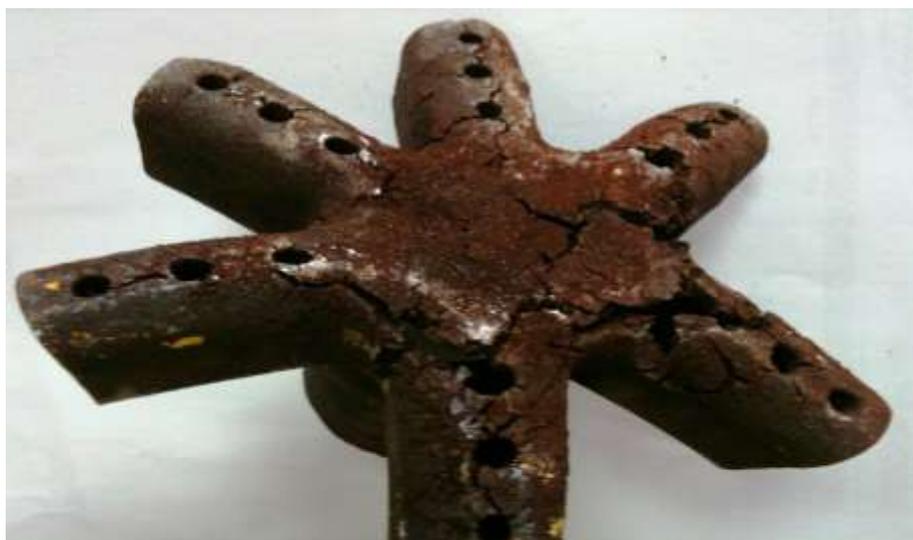
Figure 8.3 Image of a nozzle damaged due to high temperatures

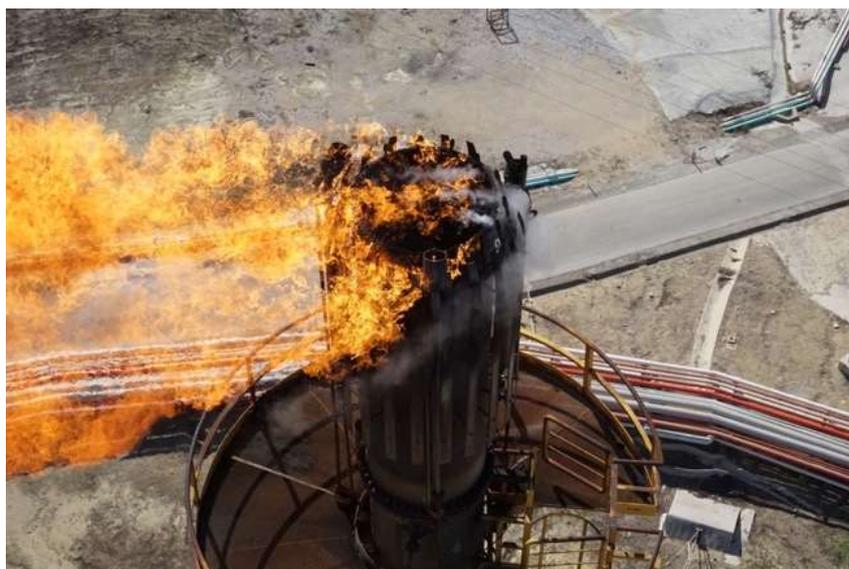
Figure 9 Image from above the burner area (tip) of a flare stack with a defect in the steam seal using a drone

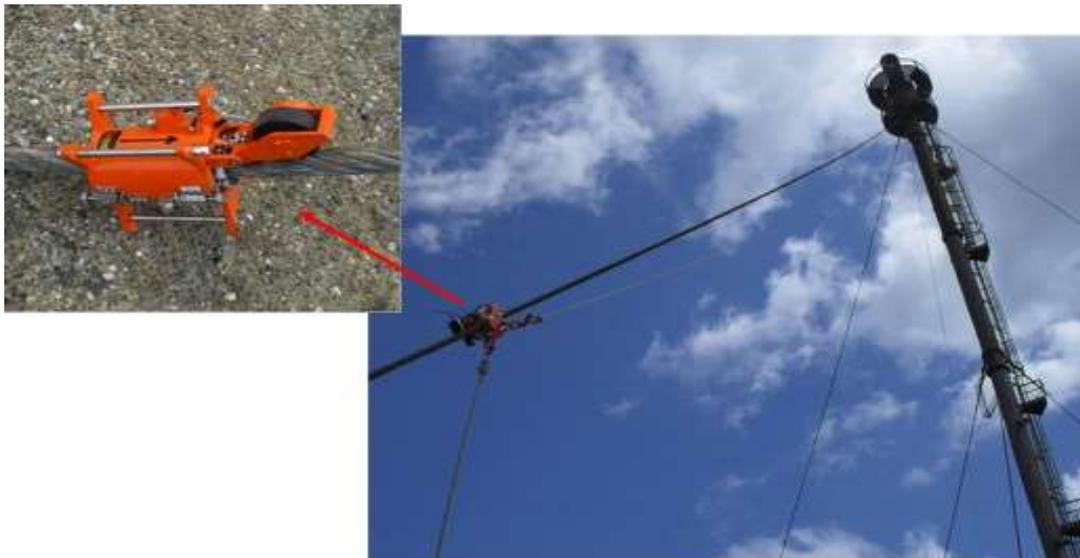
Figure 10 Magnetic head for magneto-inductive analysis, moving along the flare stack guy wire

The *magneto-inductive analysis* of the guy wires is based on the method of magnetising the wire with permanent magnets, installing a magnetic head on such and moving it along during the test. Irregularities such as loss of metallic area (LMA) and local faults (LF) lead to a redistribution of the magnetic flow around the wire, which is detected by Hall effect sensors [13, 14, 15, 16, 17, 18, 19].

It is recommendable to perform at least two inspection sweeps with the magnetic head along each wire (photo 10), and thus have at least two results sheets per wire, in order to compare these. The rejection criteria are based on the level of average loss of cross-section and the accumulation of local faults within a specific distance; as these are static wires for the supporting of structures, although there is no specific standard for these, the criteria of EN12927-6 [20] or ISO4309 [21] are generally applied, with the additional existence in Spain of UNE 58111-91 [22].
